# The San Roque Club: A new life for the Old

By Toby Ingleton

Tue 27 Apr, 2021

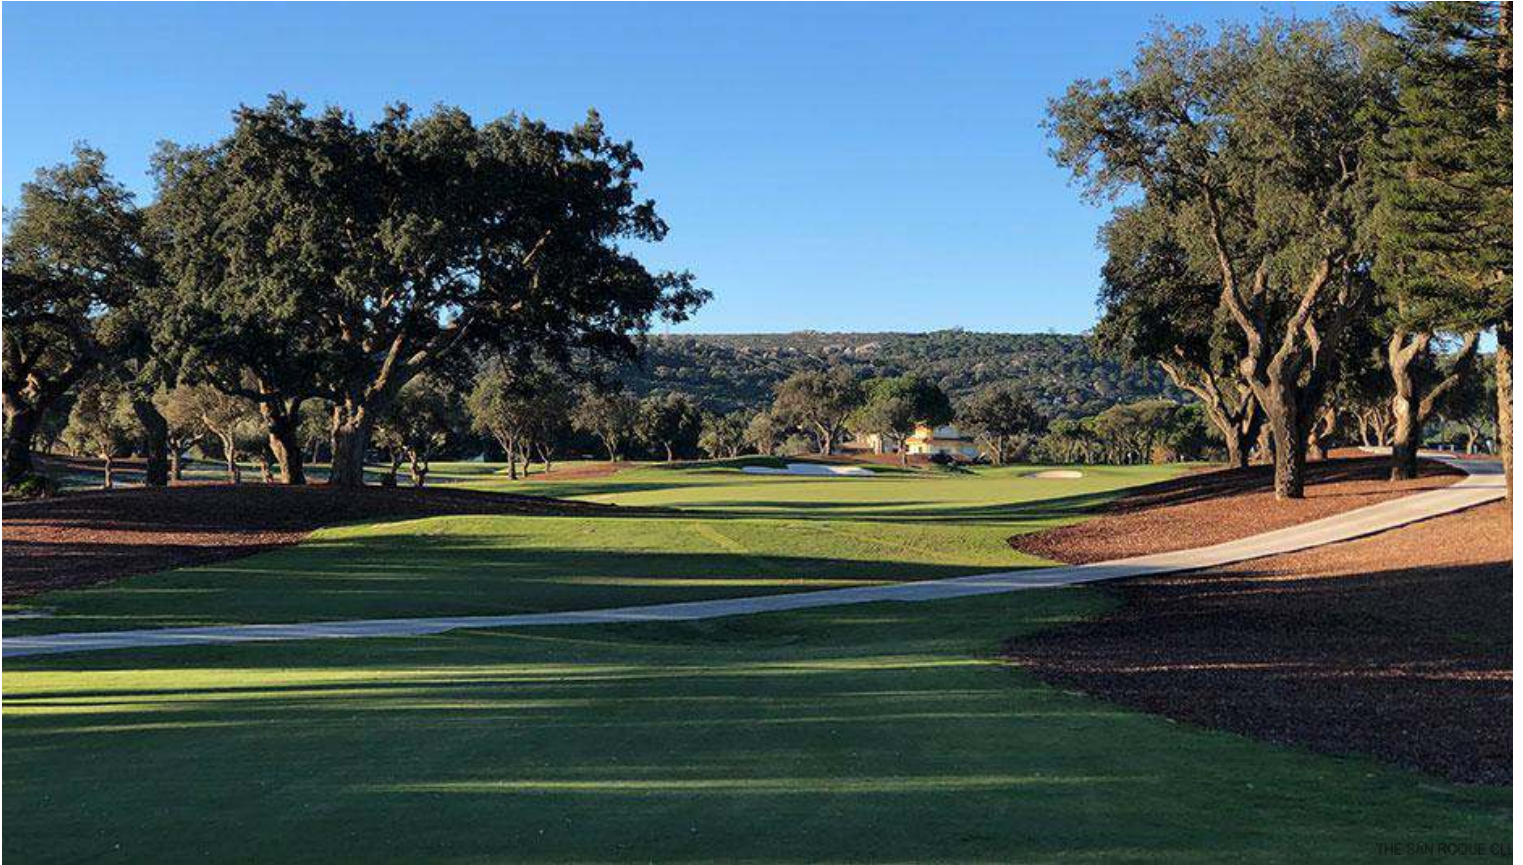
A bark mulch has been used throughout the course to reduce the amount of maintained turf, saving water and labour

“We reduced the turfed area from about 55 hectares to 37,” says Clarkin. Such a dramatic reduction was designed both to minimise the water and labour requirement for the golf course, and to give the layout crisp definition. Areas that were previously turfed are now covered with a bark mulch, delivering a similar effect to the pine straw at Augusta National. The mulch requires almost no maintenance and provides a marked contrast with turfed areas, giving the Old course an aesthetic that is quite unique in the area. Balls that come to rest on the mulch can be easily found, removing the frustrating experience of scrambling through undergrowth, but still demand a recovery shot.
