### Riverside County WMD Moreno Valley, CA

## Less waste to manage at the Riverside County WMD

### Drip retrofit leads to water and cost savings

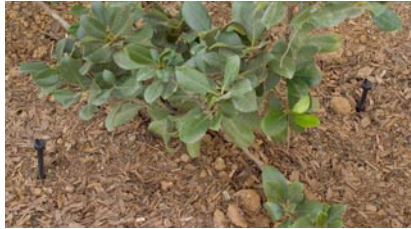
*Strategic Rain Bird® Xeri-Bug™ Emitter placement provided more efficient watering around shrub root zones.*

12" Polyflex Riser/Adapter Assemblies and Rain Bird® 2 GPH Xeri-Bug™ Emitters. Trees got their own drip systems, as well: 7 GPH Pressure-Compensating Modules for small trees and 10

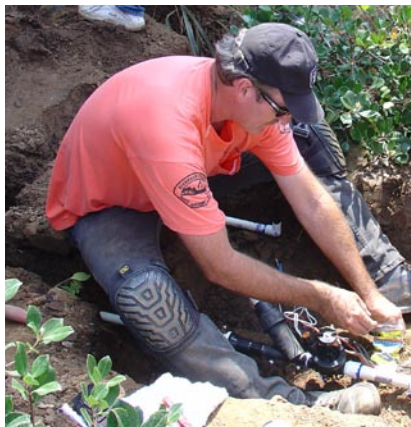
*Dave Matthews installs Rain Bird's XCZ-100 Control Zone Kit. This medium-flow kit, with its durable DV Valve and RBY Filter provided an ideal solution for the new drip irrigation design.*
